**CALIFORNIA PUBLIC UTILITIES COMMISSION**  
**Safety and Enforcement Division**  
**Electric Safety and Reliability Branch**

**Incident Investigation Report**

**Incident Number:** E20181108-01

**Utility Facilities involved:** Caribou-Palermo 115 kV Transmission Line and Big Bend 1101 12 kV Distribution Circuit

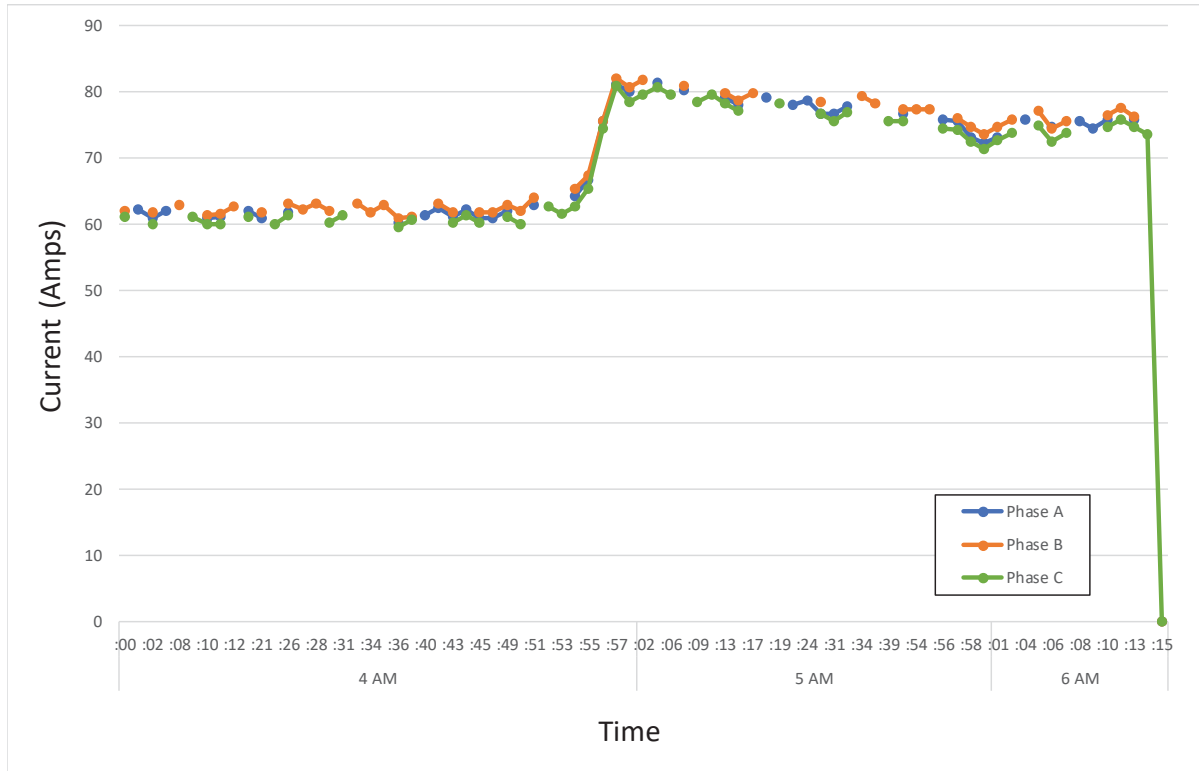
Figure 1: Chart of SCADA data recorded at Circuit Breaker 152 on the Caribou-Palermo 115 kV Transmission Line just before the incident.<sup>77</sup>

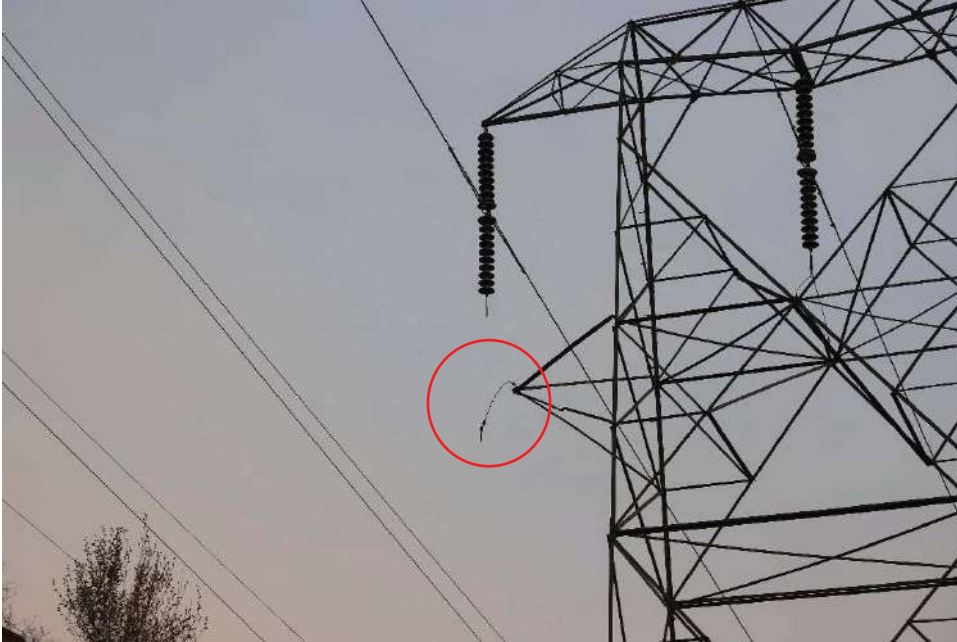
At first, SED made observations at Tower :27/221, adjacent to the Incident Tower. The distance between the two towers is approximately 845 feet.<sup>27</sup> SED observed that the hold-down anchor on Tower :27/221 had disconnected from the suspension insulator. This is shown in Figure 2.

Tower :27/221 had disconnected from a suspension insulator. PG&E assigned the condition a Priority Code E.<sup>48</sup> As defined in the ETPM Manual, the Priority E designation is for conditions which must receive corrective action within 12 months. SED notes that during additional enhanced inspections that PG&E performed after the Camp Fire, PG&E assigned a Priority A code for a separate broken hold-down insulator hardware on a different tower on the Caribou-Palermo Transmission line.<sup>49</sup> According to a PG&E lineman who was at the site on November 14, 2018 the hold-down anchor on Tower :27/221 was not broken, but rather had become unscrewed. Nevertheless, the hazardous condition created by an unscrewed hold-down anchor is similar to that created by a broken hold-down anchor. SED concludes that the unscrewed insulator hold-down anchor on Tower :27/221 should have been designated Priority A. This is a violation of GO 95, Rule 18.

Figure 2. At Tower :27/221, an insulator hold-down anchor was disconnected. Photo provided by PG&E.<sup>78</sup>

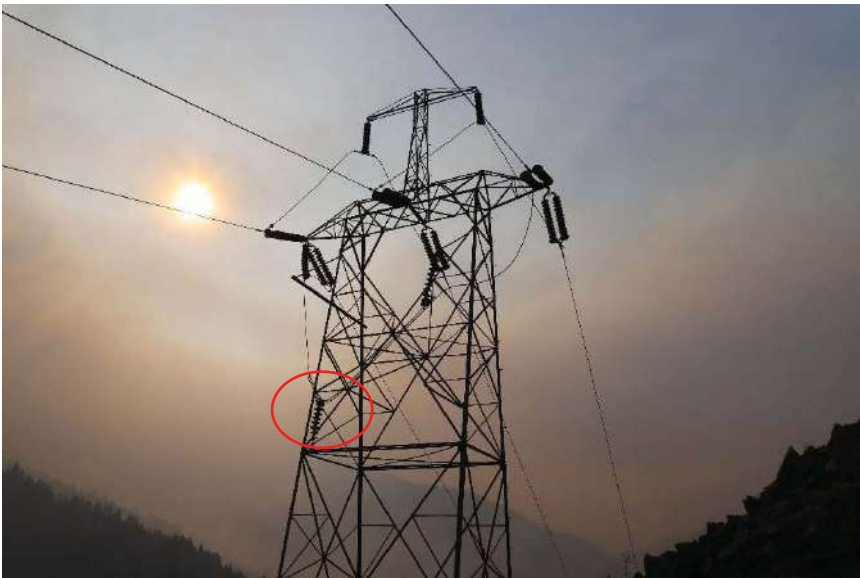
The Incident Tower is a dead-end transposition tower. On the Incident Tower, SED observed that a suspension insulator supporting a transposition jumper had separated from an arm of the tower and remained suspended above the ground (Figure 3). Prior to the failure, two C-hooks provided mechanical support to the incident transposition jumper; and each C-hook carried a load of approximately 143 lbs.<sup>28</sup> One of the C-hooks failed at the point where it had been in contact with the hanger plate. SED made a close observation of the portion of the failed C-hook that remained attached to the separated suspension insulator. SED observed that most of the cross-section was flat and smooth. At the upper portion of the cross-section – approximately the top 20 to 25 % of the cross-section of the C-hook where the failure occurred – the surface of the metal was rough, and a small, sharp piece of the material jutted out. In SED's assessment: the smooth portion is an indication of wear that occurred over a long period of time prior to failure; the rough upper portion of the cross-section fractured at the time of the incident. The observations are confirmed by the photo in Figure 4. SED also observed flash marks on the transposition jumper which SED concluded were a result of arcing between the jumper and the tower (Figure 5).

Figure 3. At the Incident Tower, an insulator detached from the hanger plate and hung upside down. Photo provided by PG&E.<sup>79</sup>

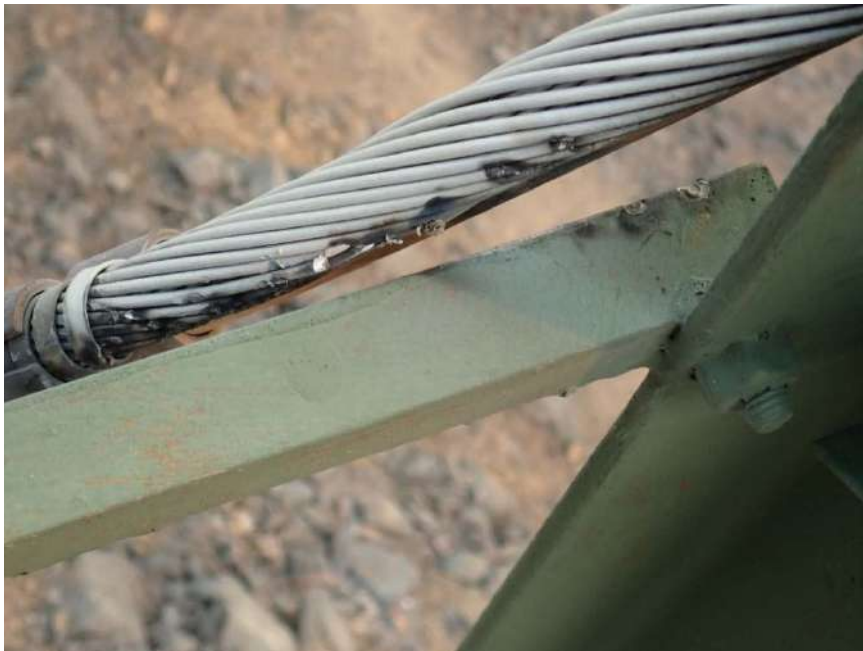
Figure 5. Flash marks on the transposition jumper and steel member on the Incident Tower. Photo provided by PG&E.<sup>81</sup>

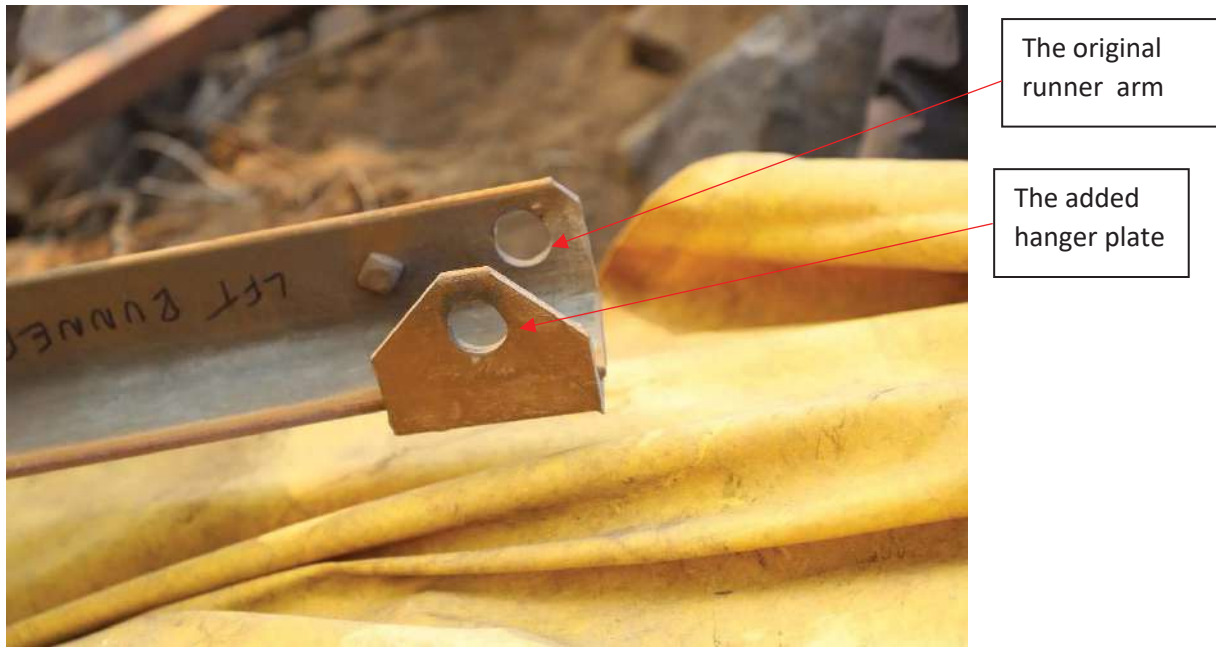
SED observed that hanger plates had been added to the left and right runner arms on the Incident Tower. PG&E could not locate records that identify when the hanger plates were added.<sup>29</sup> However, both the original runner arms, which remained in place, and the added hanger plates showed signs of wear on the working eyes as shown by

Also, the visible wear on the original runner arms on the Incident Tower (Figures 6 and 7) should have been an indication of the potential for similar problems with wear on the added hanger plates, triggering planned follow-up detailed climbing inspections. SED notes that during additional enhanced inspections that PG&E performed after the Camp Fire, PG&E assigned a Priority A code for 13 towers on the Caribou-Palermo Transmission Line where similar visible wear on the working eyes of the hanger plate was detected.<sup>59</sup>

Figure 6. The left runner arm and the added hanger plate from the Incident Tower.<sup>82</sup>

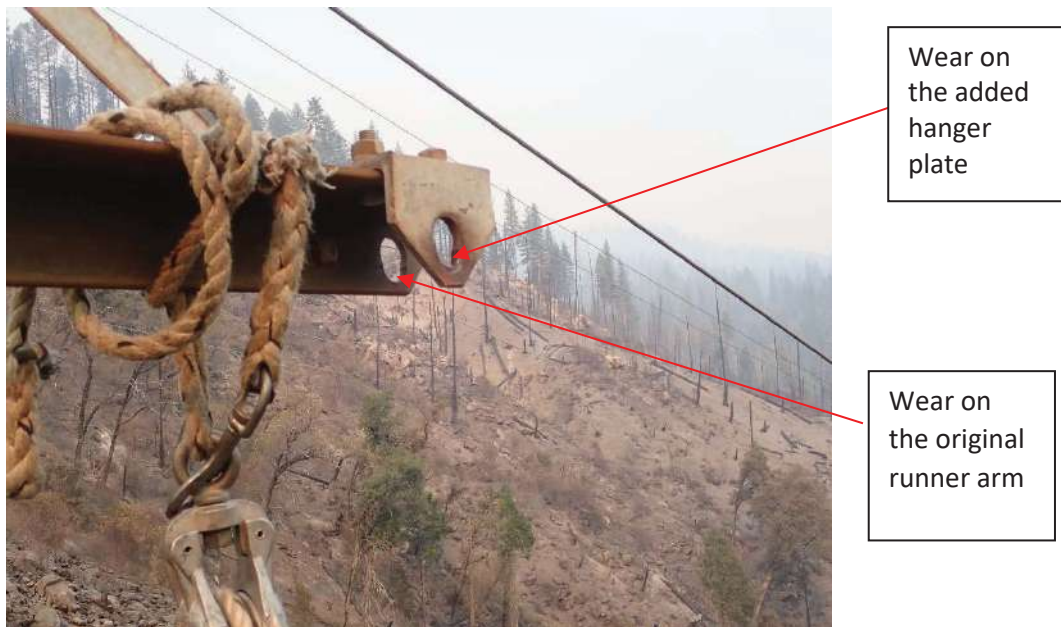
Figure 7. The right runner arm and the added hanger plate from the Incident Tower prior to removal from the tower for evidence. Photo provided by PG&E.<sup>83</sup>

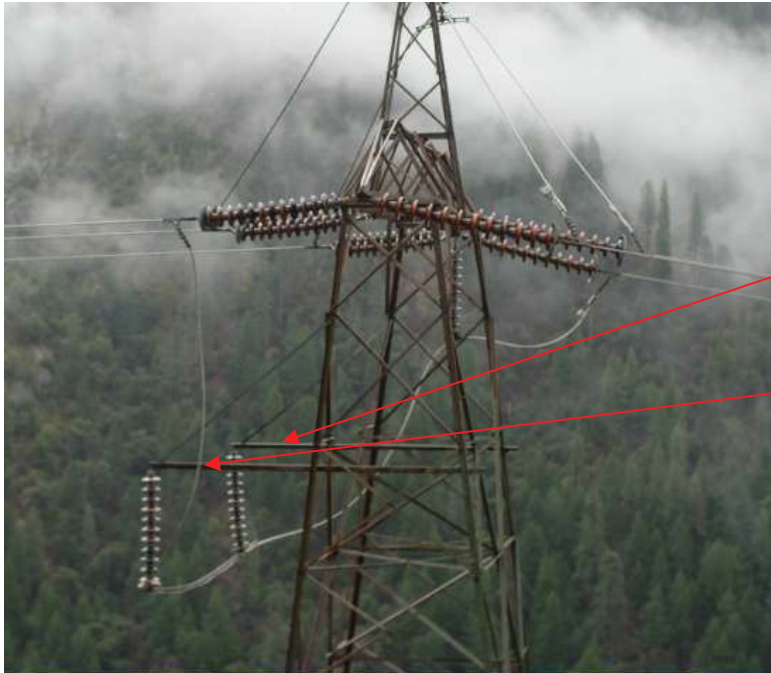
Location of the runner arms

Figure 8. Typical location of runner arms on transmission towers similar to the Incident Tower. This is PG&E Tower :20/160 of the Caribou-Palermo 115 kV Transmission Line.<sup>84</sup>
