FULL-SCALE SHELL IMPACT TEST OF A DOT-113 TANK CAR

SUMMARY

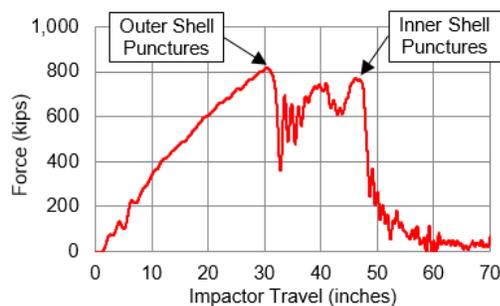
Figure 4. Test Force-displacement Results at 16.7 mph (CFC-60)

The impact occurred at 16.7 mph and resulted in puncture of the inner and outer tanks. The force-displacement results from the test are shown in Figure 4, along with annotations denoting where the outer and inner shells punctured. The force/acceleration results are taken from the average of four of the five longitudinal accelerometers on the ram. A CFC-60 filter was used on these results in accordance with the Society of Automotive Engineers (SAE) J211-1 standard. Examination of the test data revealed that the outer tank punctured after ~31 inches of impactor travel and the inner tank punctured after ~47 inches. The impactor continued to penetrate the inner tank after puncture.

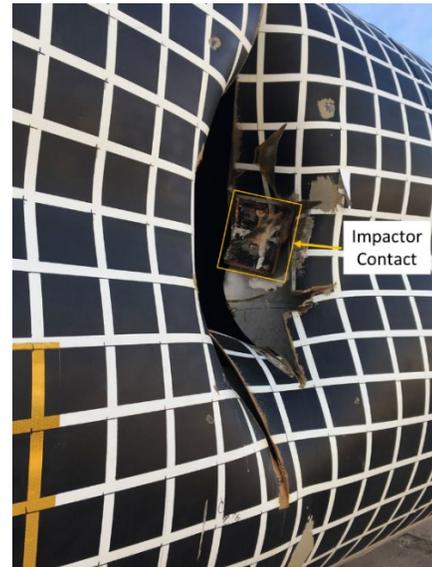
Figure 5. Post-test Tear in Outer Tank

Figure 5 shows the tear in the outer shell after the removal of the ram car. The tear appears to have initiated under a corner of the impactor and propagated vertically, which is consistent with previous tests and pre-test FEA for this test. No welds were involved in tearing of the outer tank. Red paint transfer from the impactor's tip is highlighted in this image as evidence of impactor contact.
