## NATIONAL TRANSPORTATION SAFETY BOARD

### Group Chairman's Factual Report

# Operations

**Location:** Off Channel Islands; 26 nautical miles offshore of Ventura, California  
**Date:** September 2, 2019  
**Type:** Fire/explosion  
**NTSB #:** DCA19MM047

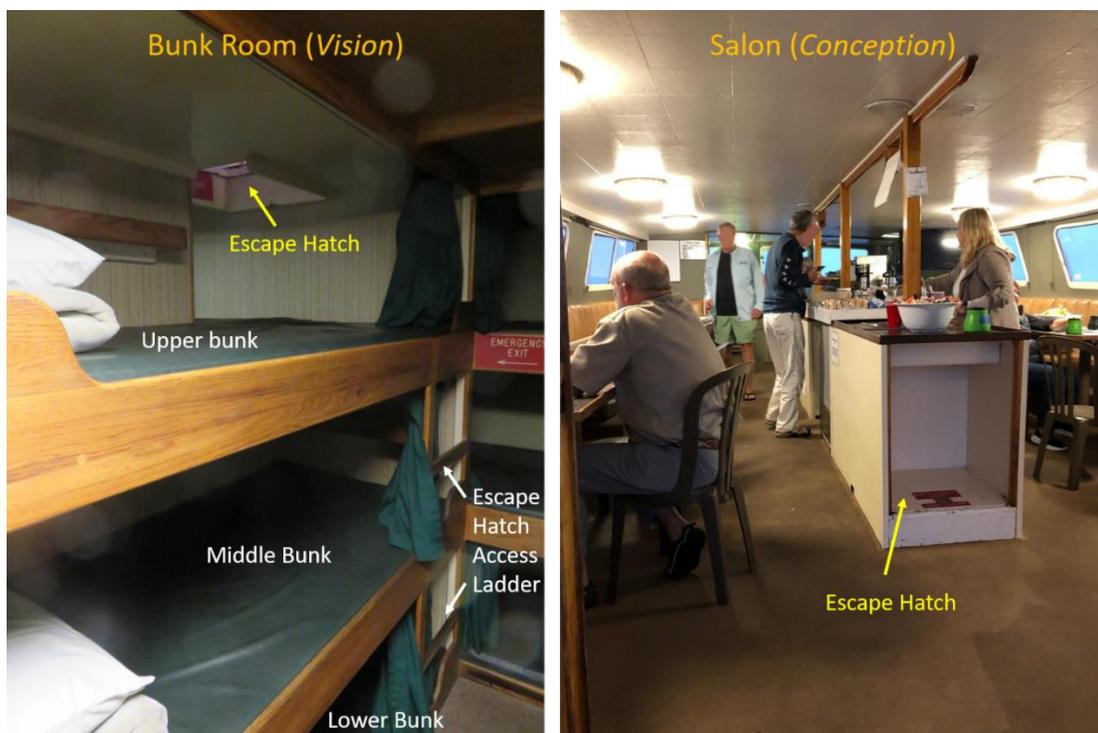
An escape hatch provided an alternate means of exiting the bunkroom (the stairway at the forward end was the primary means). The escape hatch, which consisted of a removeable wooden panel that was about 22-inches-by-22-inches in size, was located in the overhead between the aftmost centerline bunks.<sup>3</sup> It could be reached from either aisle by climbing a wooden ladder installed on the side of each centerline aft set of bunks. The hatch exited into the rear of the salon, and thus both escape routes from the bunkroom exited into the salon. When the *Conception* was constructed and underwent sea trials in 1981, the Coast Guard “Sea Trials; T new construction and conversion” inspection form required the attending Coast Guard inspector to “physically use each emergency escape on board.” The inspection item was checked as completed on the form. The inspector wrote on the signed form that the sea trials were satisfactory.

**Figure 4.** Photo left is the escape hatch, viewed from the bunkroom, on the *Vision*, a Truth Aquatics dive vessel with arrangements nearly the same as the *Conception*. (Source: NTSB) Photo right is the escape hatch, viewed from aft in the salon, on the *Conception*. (Source: J. Palmer)

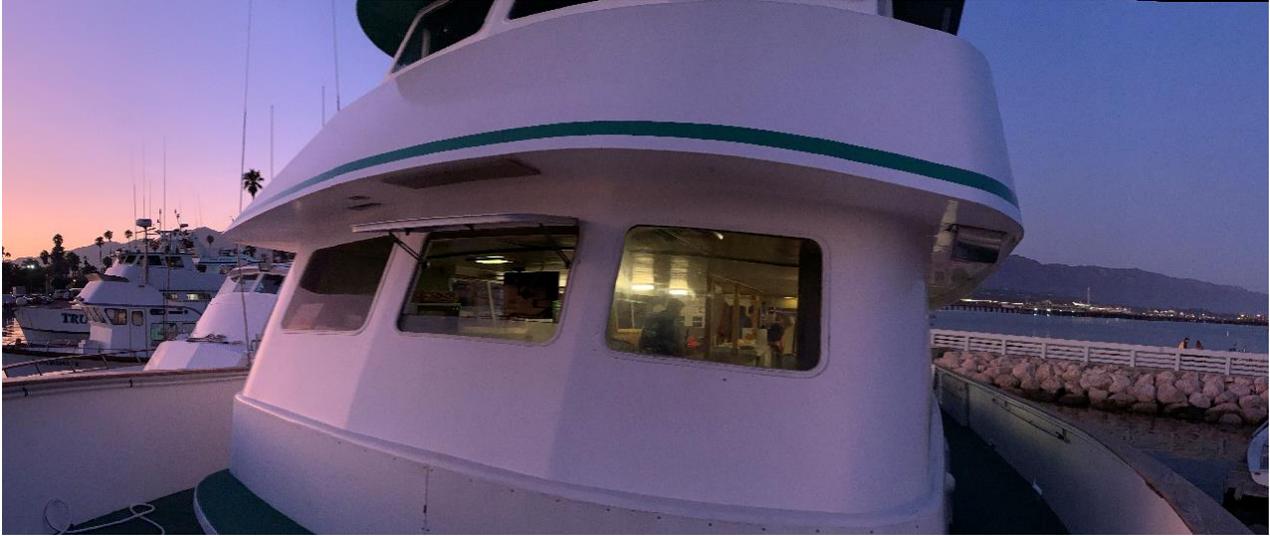
After the first deckhand had lowered himself down to the main deck, he looked aft and saw that the port exterior walkway was blocked by smoke and flames coming out of the salon windows and wrapping around the sun deck above. He proceeded to the bow and tried to open the center window on the forward bulkhead of the salon. The deckhand, aided by the second galleyhand, struggled to pry the window open, but could not. The two crewmembers told investigators that the window was warm, but not hot, and when they looked through the window, the view was completely obscured by thick black smoke.

**Figure 6.** Preaccident photo of *Conception* forward salon windows. In this photo the center window is open. However, during the accident, the window was closed and secured as the crew attempted to access the space. The port and starboard windows were not designed to be opened. (Source: T. Thompson)

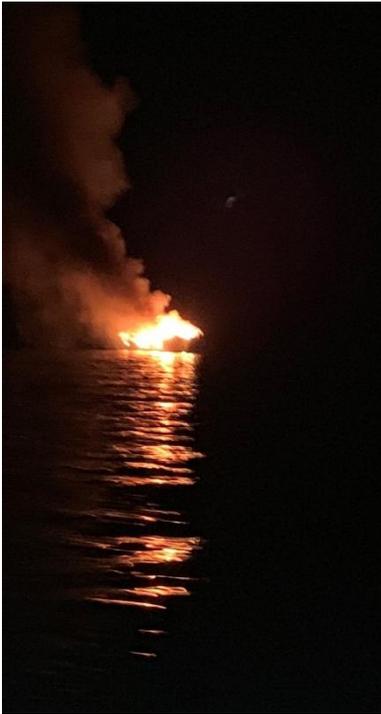
**Figure 7.** Cell phone photo of *Conception* on fire, taken from sportfisher *Grape Escape*. (Source: S. Hansen)
