Robb Elementary School Attack Response Assessment and Recommendations

Introduction

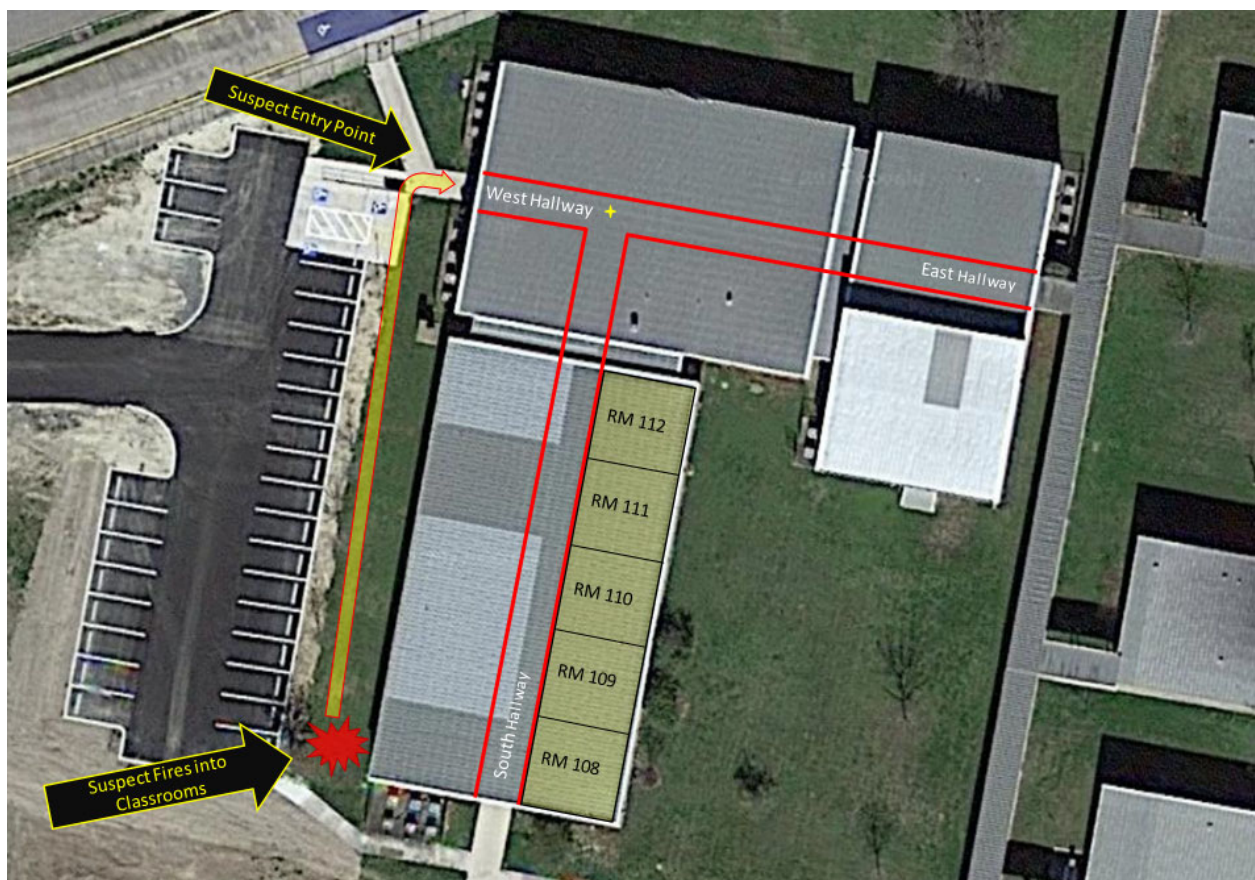
Figure 2. Suspect Entry Point

At 11:27:14, a female teacher (Female 1) exits the exterior door in the west hall propping the door open with a rock to prevent it from closing behind her (see Figure 2 for suspect entry point). (ISS)

At 11:32:08, the suspect reached the west teachers' parking lot adjacent to the affected building and fired through windows into the westmost rooms prior to entering the building. (FH and audio file from ISS)

We identified three key issues that occurred prior to the suspect gaining entry to the building. First, a teacher propped open the exterior door at 11:27:14. ALERRT staff noted rocks (some of which were painted) were placed at most external doors of the building. Based on this observation, it appears that propping doors open is common practice at this school. While the teacher did kick the rock and close the door prior to the suspect making entry, and the propping open of the door did not affect what happened in this situation, circumventing access control procedures can create a situation that results in danger to students. After the teacher closed the door, she did not check to see if the door was locked. Perhaps this was because the door is usually locked. However, on this day the door was not locked, and because it was not locked, the attacker was able to immediately access the building. This again highlights the importance of not circumventing access control procedures. Even if the teacher had checked to see if the door was locked, it appears that she did not have the proper key or tool to engage the locking mechanism on the door. Finally, we note that the door was a steel frame with a large glass inlay. This glass was not ballistic glass, nor was there film on the glass to maintain the integrity of the door if the suspect shot the glass. This suggests that the suspect would have been able to gain access to the building even if the door was locked.

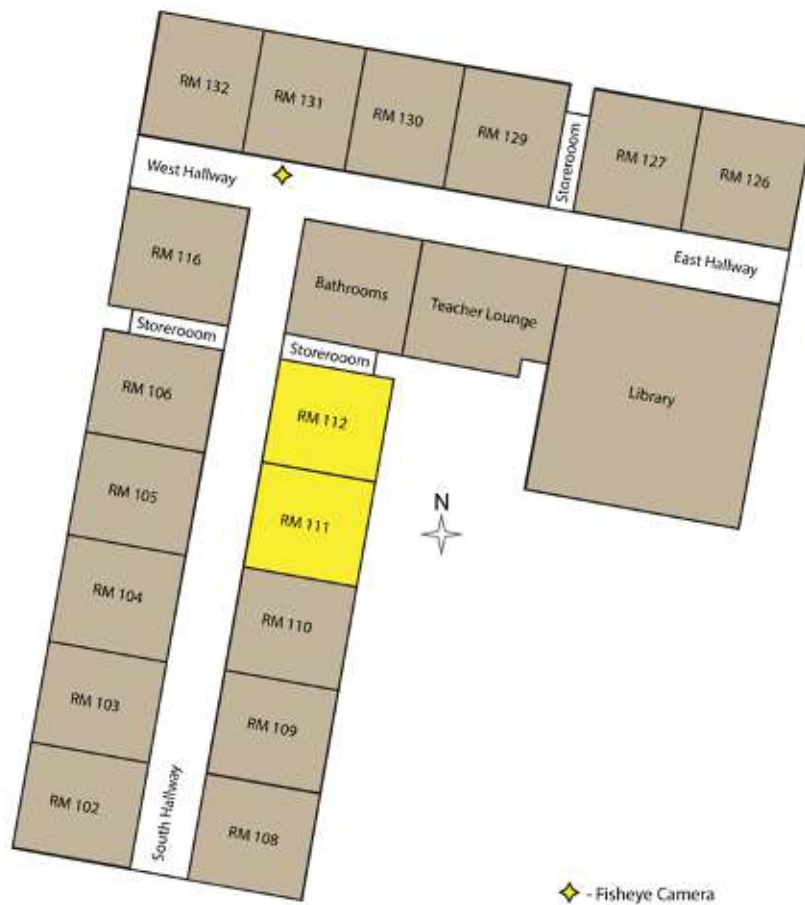
Figure 3. West Building Layout

Note: *The internal school surveillance (ISS) video consisted of a ceiling-mounted camera that was situated at the intersection of three intersecting hallways (as indicated by the yellow star in Figure 3) This camera captured 1) the suspect's entry point, which was the short (West) hallway leading to an exterior door; 2) a second long hallway (South) with multiple classrooms on either side of the hall and an exterior door at the southmost end of the hall; and 3) a third hallway (East) that leads to other classrooms, restrooms, a teachers' lounge, a library, and an exterior door at the eastmost end of the hallway.*

The exterior walls of each classroom had two 3' x 4' windows near the opposing corners of each classroom (see Figure 3). The bottom of each window was approximately 3' from interior floor level, and they were equipped with mini blinds. From the exterior, the windows were approximately 4' from ground level. The windows were composed of a heavy aluminum frame with three lateral cross beams that held four (4) 1'x3' panes of tempered glass, as seen in Figure 7.

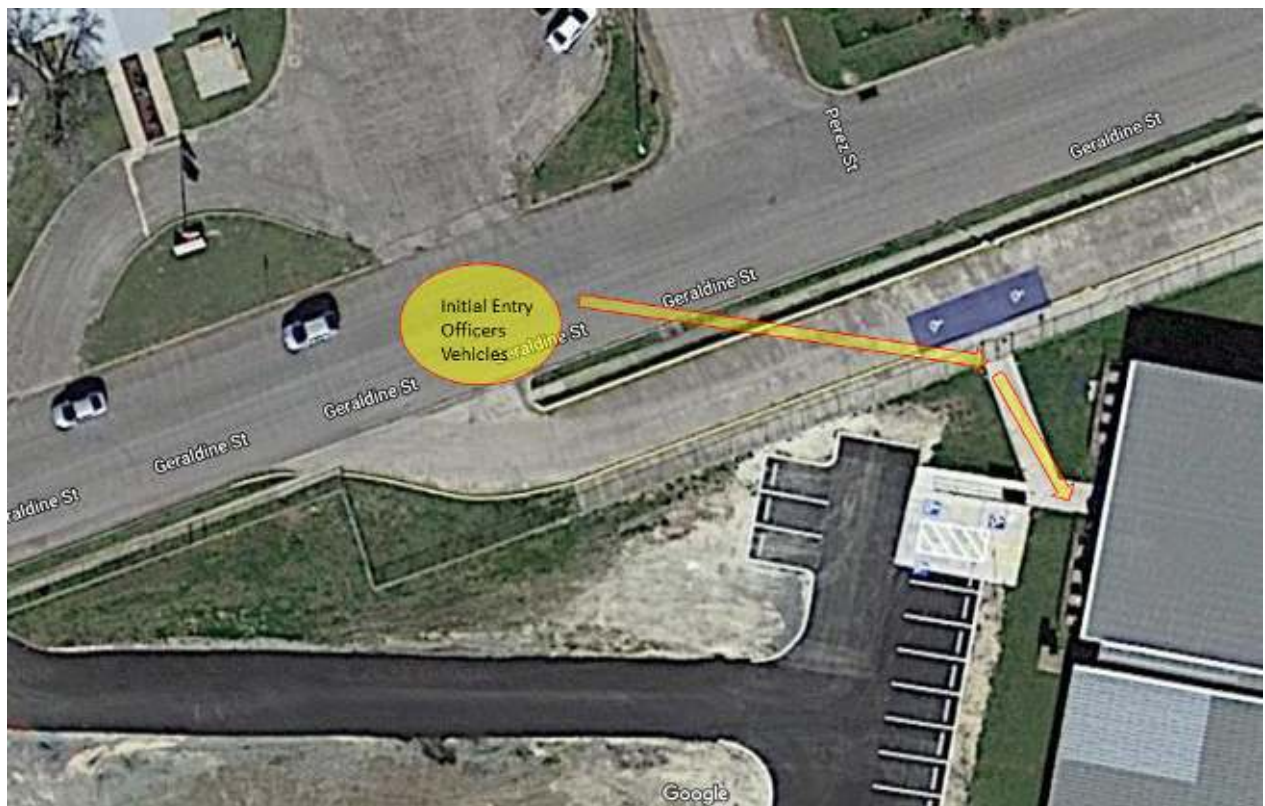
Figure 4. Officers Initial Entry into West Building

After the suspect made entry into the west building, three Uvalde Police Department (UPD) officers gathered on Geraldine Street (behind police vehicles) in front of the school drop-off / pick-up area. Then the officers, using a bounding overwatch tactic, move quickly (one at a time) to the west door.

At 11:35:55, all three Uvalde Police Department (UPD) officers entered the structure through the west door into the west hallway. These officers were equipped with the following: one with external armor and two with concealable body armor, two rifles, and three pistols. At 11:36:00, four officers entered the south hallway through the south door closest to the suspect. It is not clear what equipment these officers had with them. Four more officers entered the west hallway through the west door at 11:36:03. Three of these officers were from the UPD and one was from the Uvalde Consolidated Independent School District Police Department (UCISD PD). They were equipped with three external body armor carriers and one with concealable body armor and pistols. (ISS)

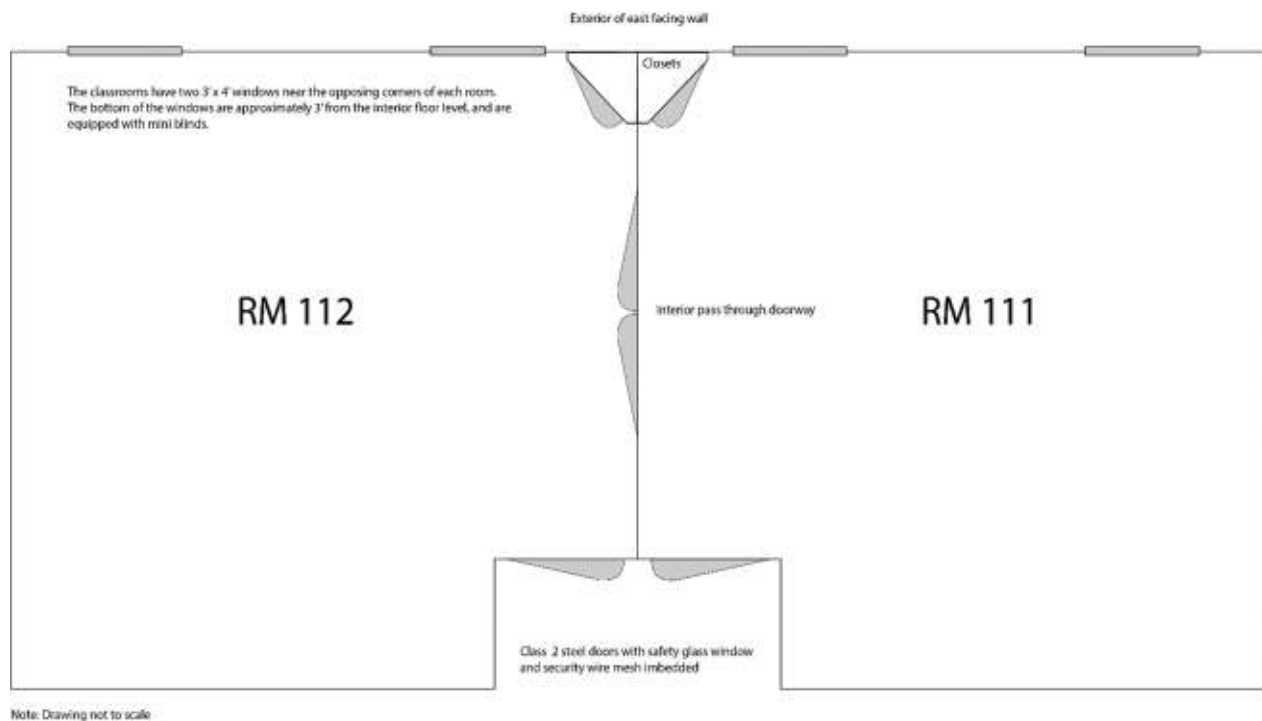
Figure 5. Classroom Layout

The classroom doors were inset just over 36” into a 90-degree inset from the hallway to accommodate the swing of the outward opening classroom doors towards the hall. Each inset had two separate doors, side-by-side, leading into a separate classroom. The door on the left-hand side of the inset opened outward from right to left, and the door on the right-hand side of the inset opened outward from left to right as seen in Figure 5.

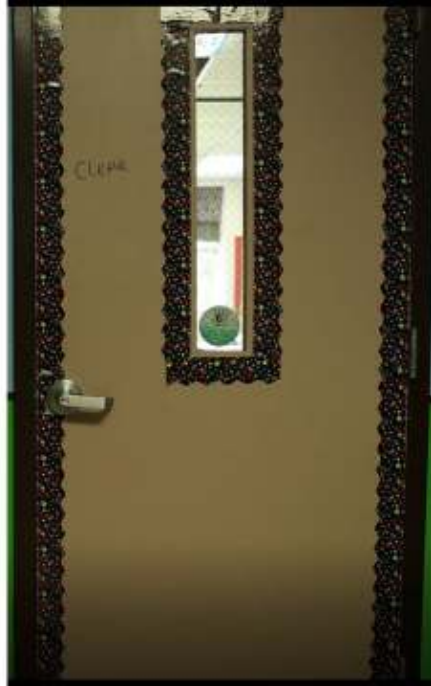
Figure 6. Class 2 Steel Door

The classroom doors were class 2 steel doors. The classroom doors had safety glass with security wire mesh imbedded (see Figure 6). The hardware consisted of a single metal door handle locking latch, three exterior metal hinges, and a door closure device mounted to the top inside portion of the door. The door jambs were composed of steel and set in a metal stud and sheetrock wall.

We identified three key issues that occurred before the suspect entered rooms 111 and 112 for the last time. First, Uvalde ISD had protocols in place requiring doors to remain locked at all times, and the school was currently on an active lockdown prior to the suspect gaining entry to the school. The suspect was still able to gain access to room 111. We received information from the investigating officer that the lock on room 111 had been reported as damaged multiple times; however, this has not been confirmed through work orders at this time. Regardless, the suspect is seen entering the room, exiting the room, and then reentering the room again prior to officers entering the building at 11:35:55. The only way to engage the lock is to insert a key from the hallway side of the door. At no point is the suspect observed entering the hallway and engaging the locking mechanism. Based upon this, we believe that the lock to room 111 was never engaged.

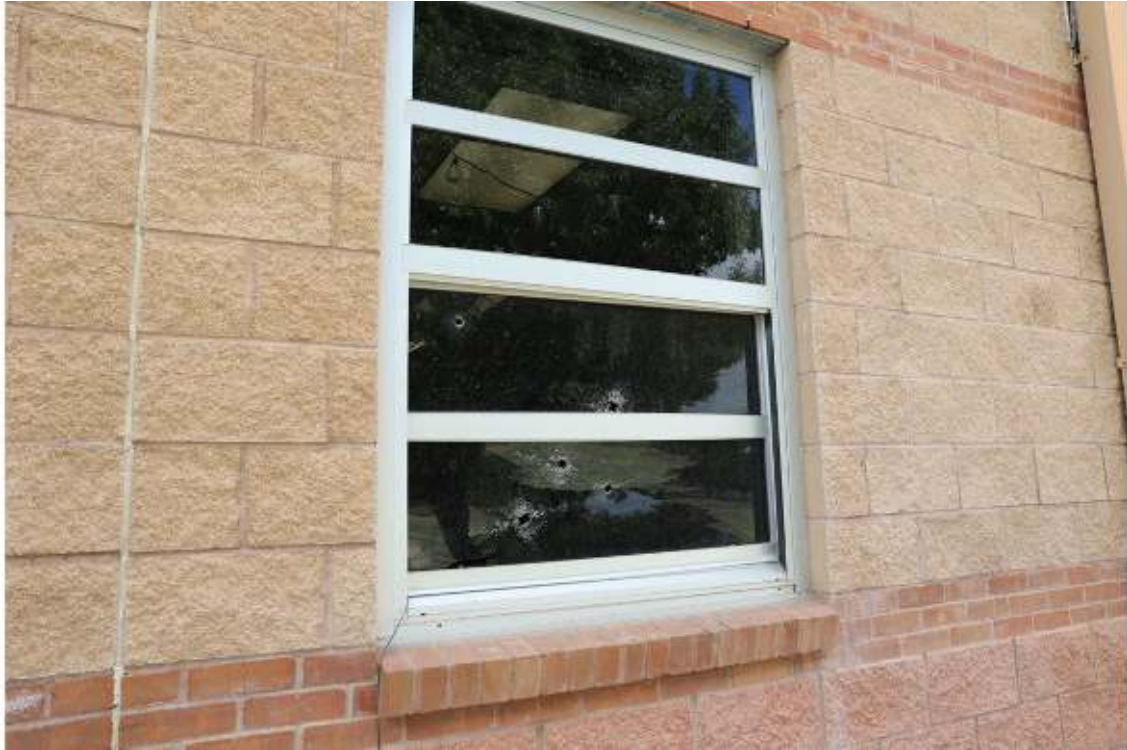
Figure 7. Exterior Classroom Window

An exterior window on the right-hand side as you enter room 111 had a clear bullet defect. Based on the fragmented spiderweb pattern it was evident that the window was composed of safety glass, which fragments into small pieces when it is struck with enough force to break.

An assessment of the classroom closet, on the exterior wall, which is directly opposite of the classroom door, revealed that the exterior wall was cinder block on the inner portions and decorative brick on the exterior (as seen in Figure 7).

- B. If the officers believed that they could not establish control through the doors, they should have found another way to stop the killing and dying. One option would have been to breach the exterior windows of the classrooms. Ideally, this would have involved breaking more than one window simultaneously and then raking the blinds out of the window. It is likely that the suspect would have fired at the officers, but the exterior construction of the building would have provided them with good cover. After the windows were broken (i.e., ported), the officers could have planned to simultaneously stand up in the windows to confront the attacker (i.e., cover). The room would have been substantially darker than the bright exterior conditions at the time. However, breaking the windows and raking the blinds would have increased lighting in the room. Hand-held or weapon-mounted lights could also have been used to increase visibility (see Supplementary information regarding an assessment of breaching options).

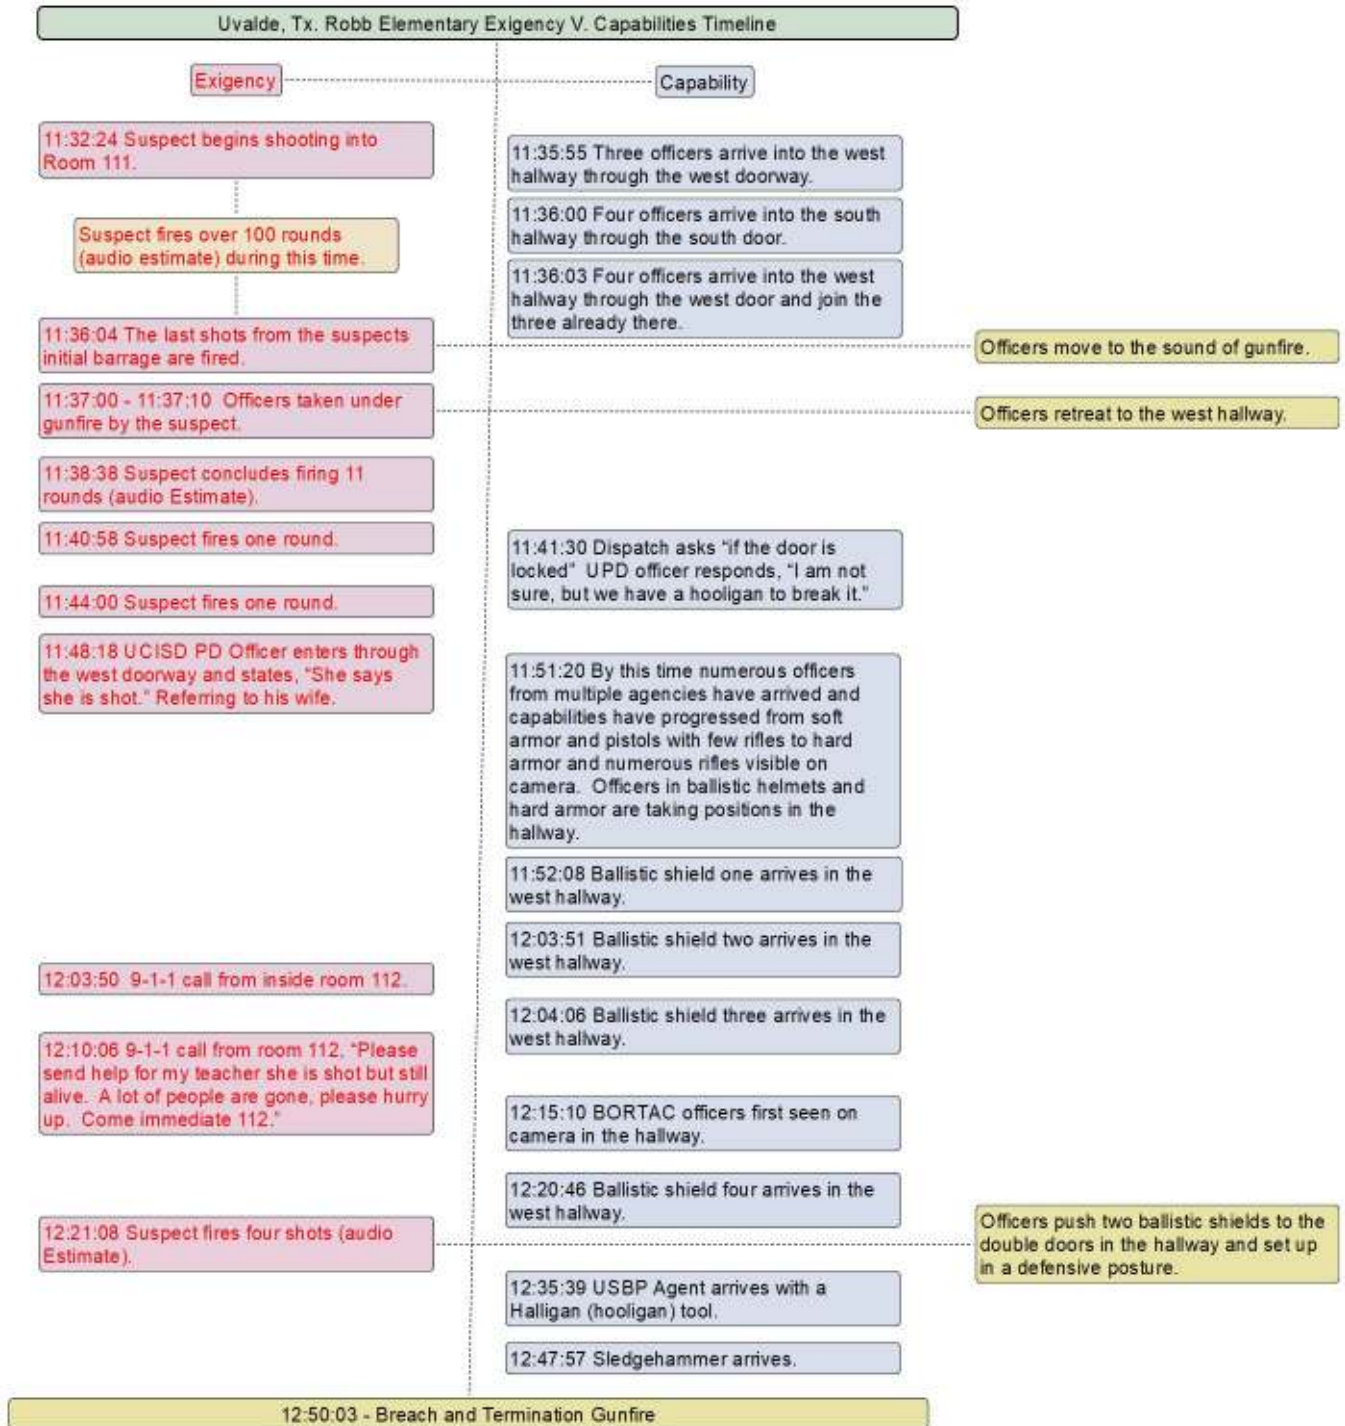
Figure 8. Exigency vs Capability Timeline

We identified two factors that we believe increased the exigency of the situation and should have prompted officers to execute an immediate action plan. These factors were ongoing gunfire and the presence of injured people.

In addition to information that should have increased the exigency of the situation, a variety of factors increased the capabilities of the officers while dealing with these threats. These included breaching tools, shields, tactical operators, and CS gas. Please refer to Figure 8 on page 20 for a detailed timeline of the factors that increased both exigency and officer capability.

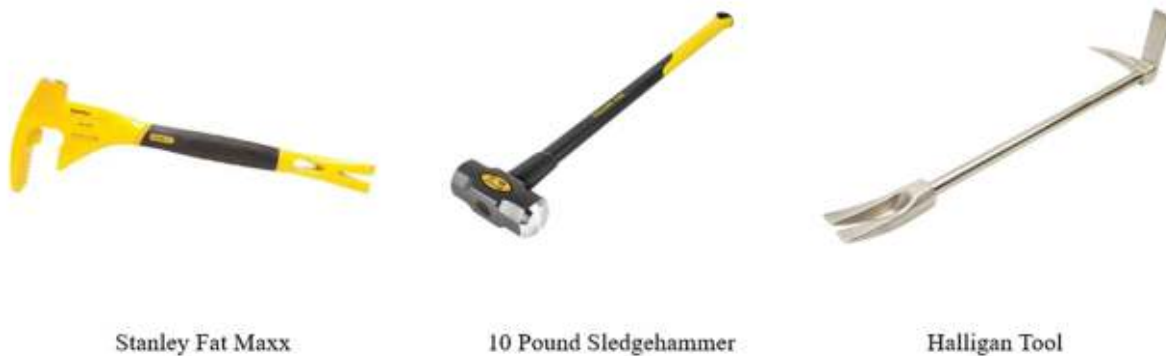
Figure 9. Breaching Tools

ALERRT staff conducted a series of tests at Robb Elementary School incorporating critical thinking and breaching techniques to determine possibilities that may have changed the incident outcome. ALERRT staff used non-traditional tools that can be purchased at most any hardware store or obtained from a firetruck. The tools used were a 10LB sledgehammer, a Stanley Fat Maxx, and a Halligan tool (see Figure 9).

Breaching Tools. A UPD officer stated that they had a Halligan at 11:41:30 when asked by dispatch if the doors were locked. This tool was not seen on camera, and if he was referring to the tool being on scene or at the UPD is unclear. A Halligan tool was captured on camera at 12:35:39. A USO deputy arrives on scene with a sledgehammer at 12:47:57. This completed the toolset needed to breach an outward opening door.
