FULL-SCALE SHELL IMPACT TEST OF A DOT-113 TANK CAR

SUMMARY

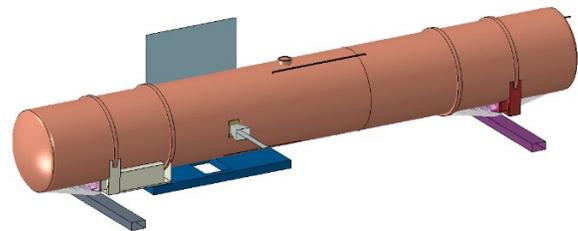
Figure 3. DOT-113 FE Model

An FEA was performed in conjunction with the test. A schematic of the FE model is shown in [Figure 3](#). This model featured simplified modeling of the water and the air within the tank. The water was modeled using a hydraulic cavity approach, and the air was modeled as an ideal gas using a pneumatic cavity. The tanks were modeled using shell elements, except in the impact zone. The impact zones of both the inner and outer shells were modeled using solid elements, with elastic-plastic and ductile failure material properties defined. This combination of shell and solid element types allowed puncture of the tank car to be modeled while reducing the model’s run-time.
